**fib Symposium**2025

# 3-years results on the corrosion of PerfDuB specimens exposed to chlorides on natural ageing site (PerfDuB project)

**Elisabeth Marie-Victoire (LRMH, CRC-UAR 3224, France)**

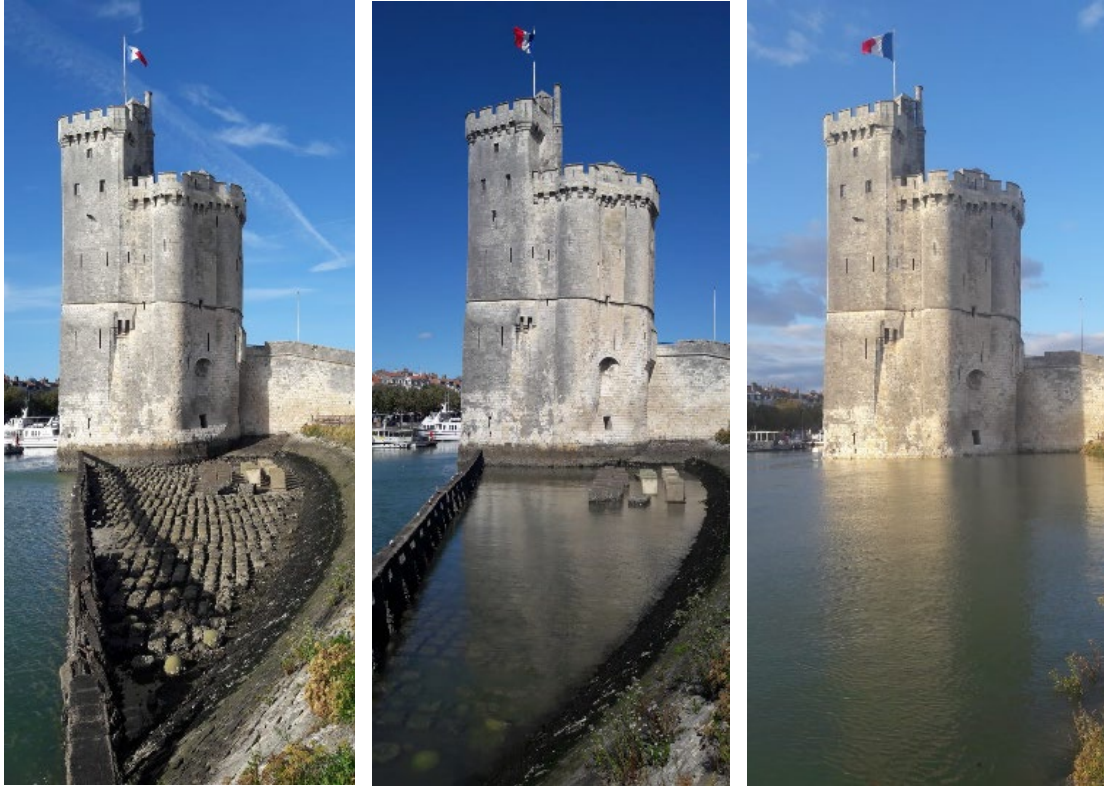
- Specimens without sensors cast from December 2019 to January 2020
- 1 year of ageing in semi-rural environment
- Installation in La Rochelle harbor in December 2020 → **XS3m**
- **Tidal zone** : 6 hours immersed, 6 hours in open air for every tide
- First set of NDT in October 2021 and annual follow-up examination

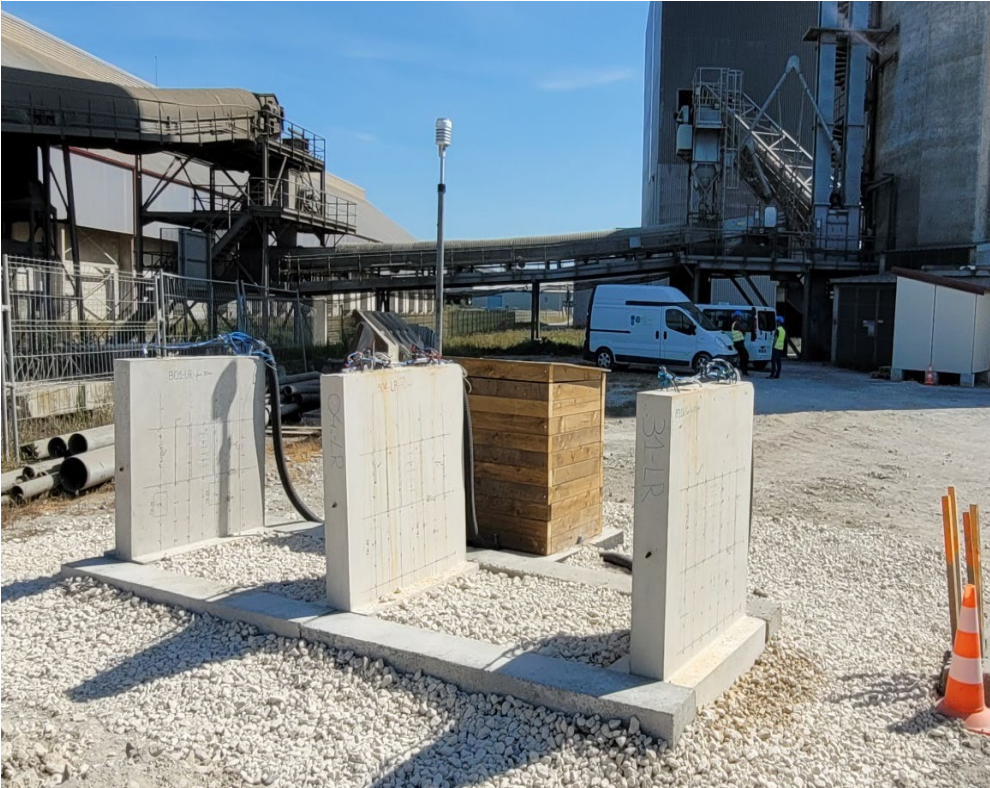
- Specimens with sensors cast from June 2021 and August 2021
- 8 months of ageing in semi-rural environment
- Installation in La Pallice industrial harbor in May 2022 → **XS3e**
- First set of NDT in May 2022 and annual follow-up examination

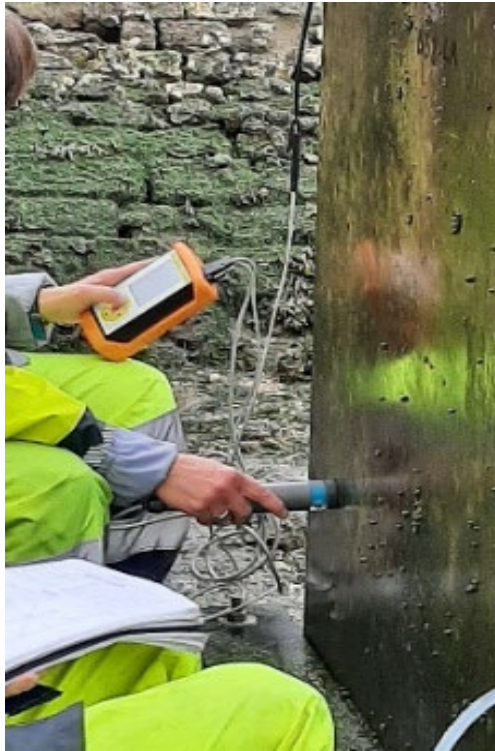
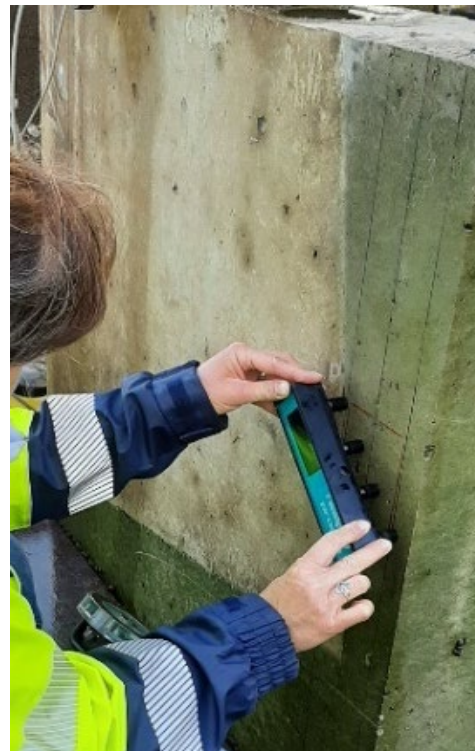
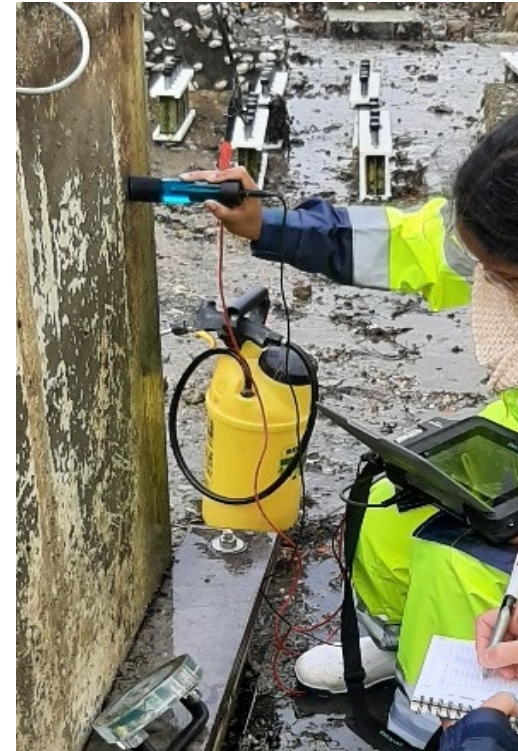
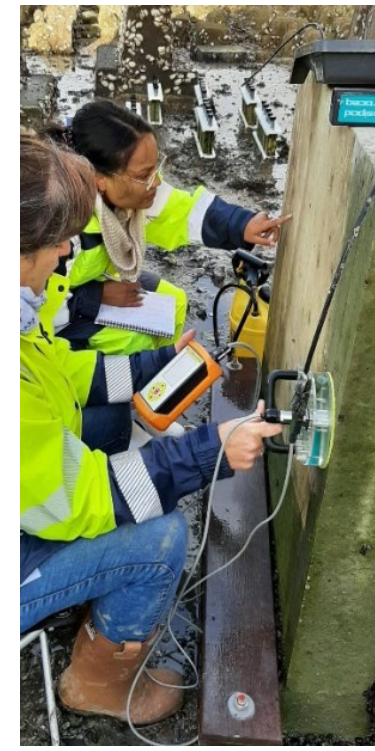
- **Resistivity** → Disc and Wenner 4-points methods
- **Potential mapping** → Cu/CuSO<sub>4</sub> reference electrode
- **Polarization resistance** → Gecor10<sup>®</sup>

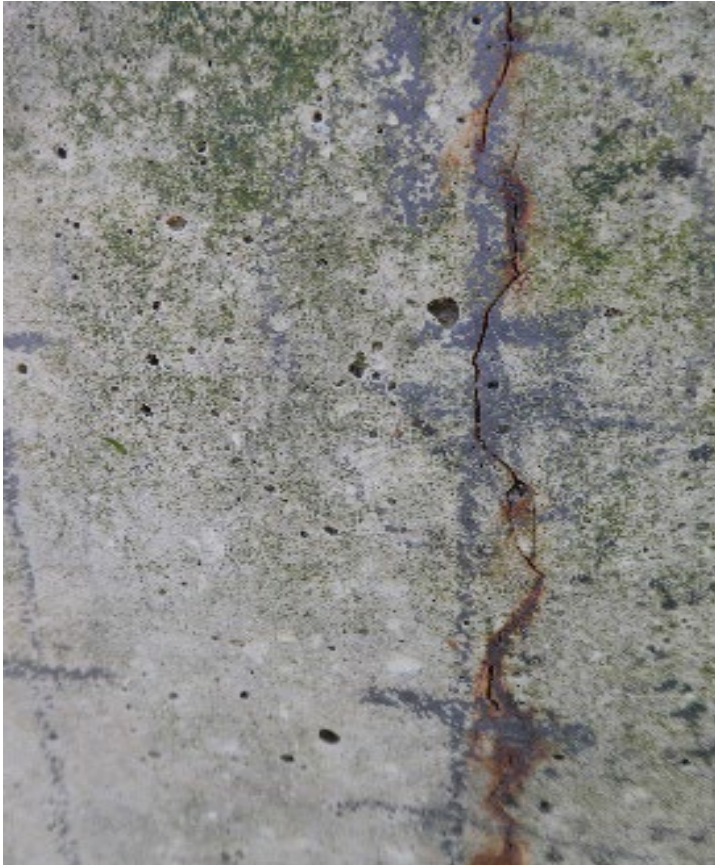
B36 – RL10

- After three years for some specimen **significant gradients**
- Indicative of a **probable corrosion** according to the RILEM recommendation
- In the gradient zones clear correlation with the appearance of **rust stains and cracks**

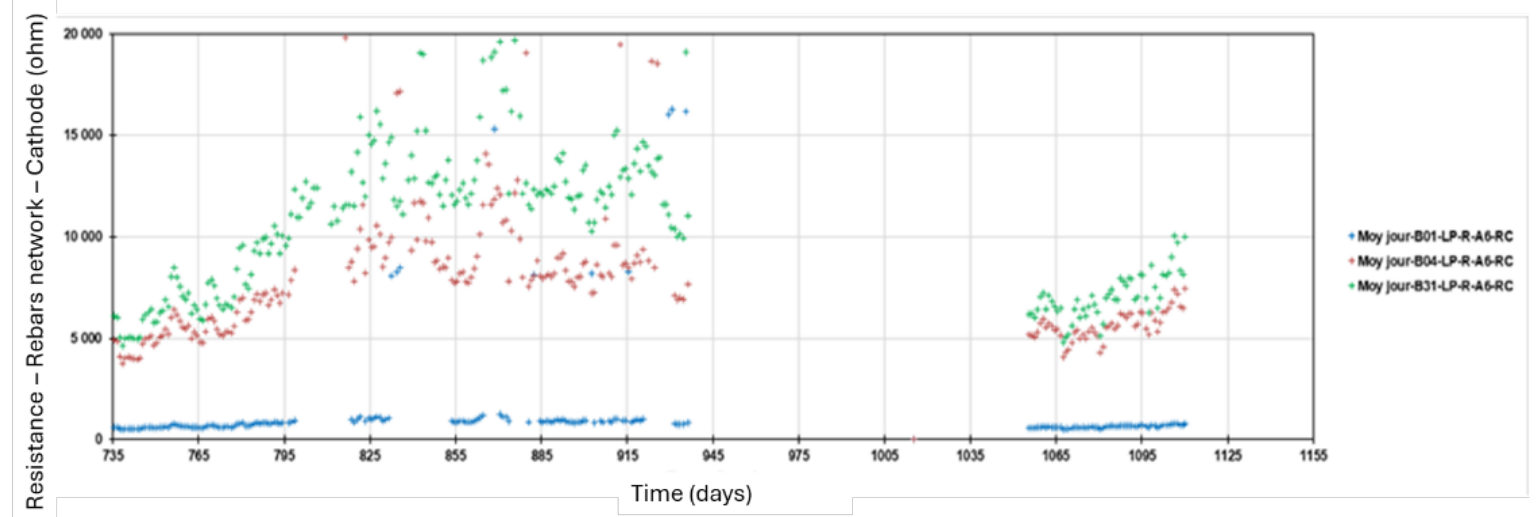
- Clear correlation between **rainfall** events and **resistance** evolution (Already evidenced by previous studies )

- **Highlights the limitations of instant non-destructive techniques**
- **And the contribution of permanent monitoring to a more precise understanding of corrosion risk evaluation and evolution**
